# Crown battery site

## Crown Battery Site

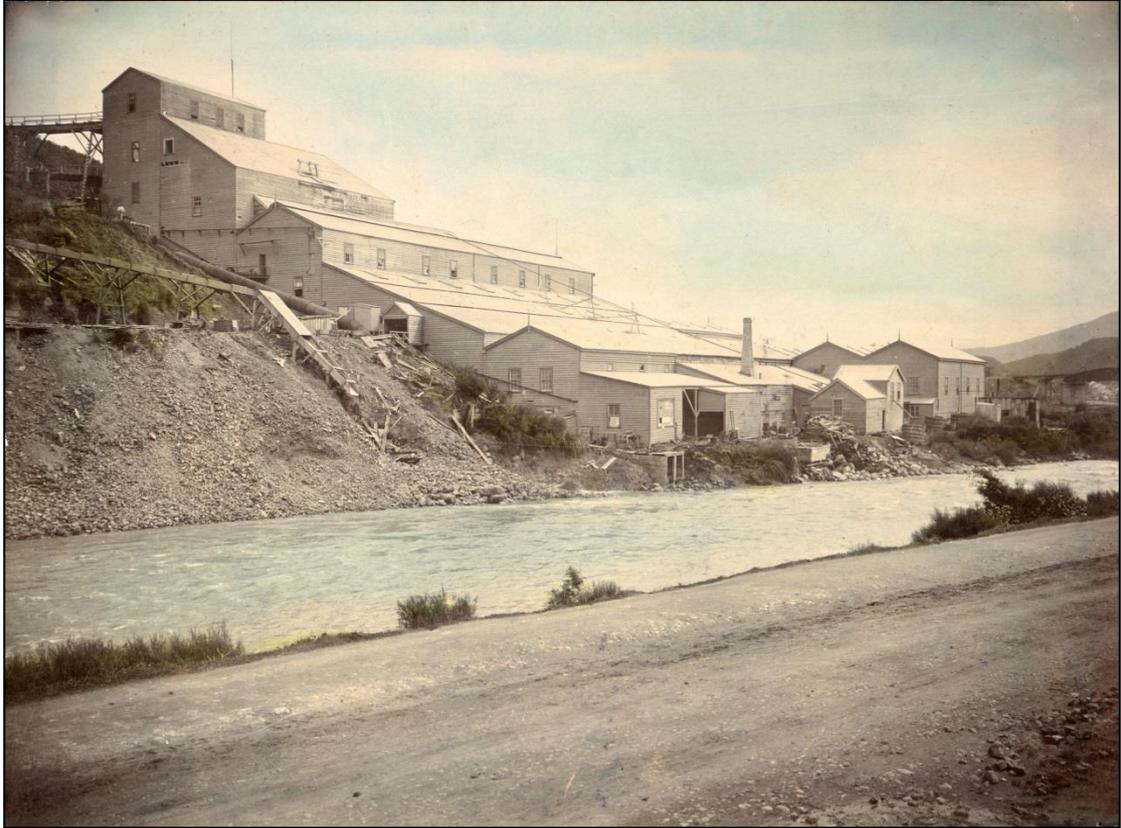
Crown Battery, c. 1906. DoC Thames

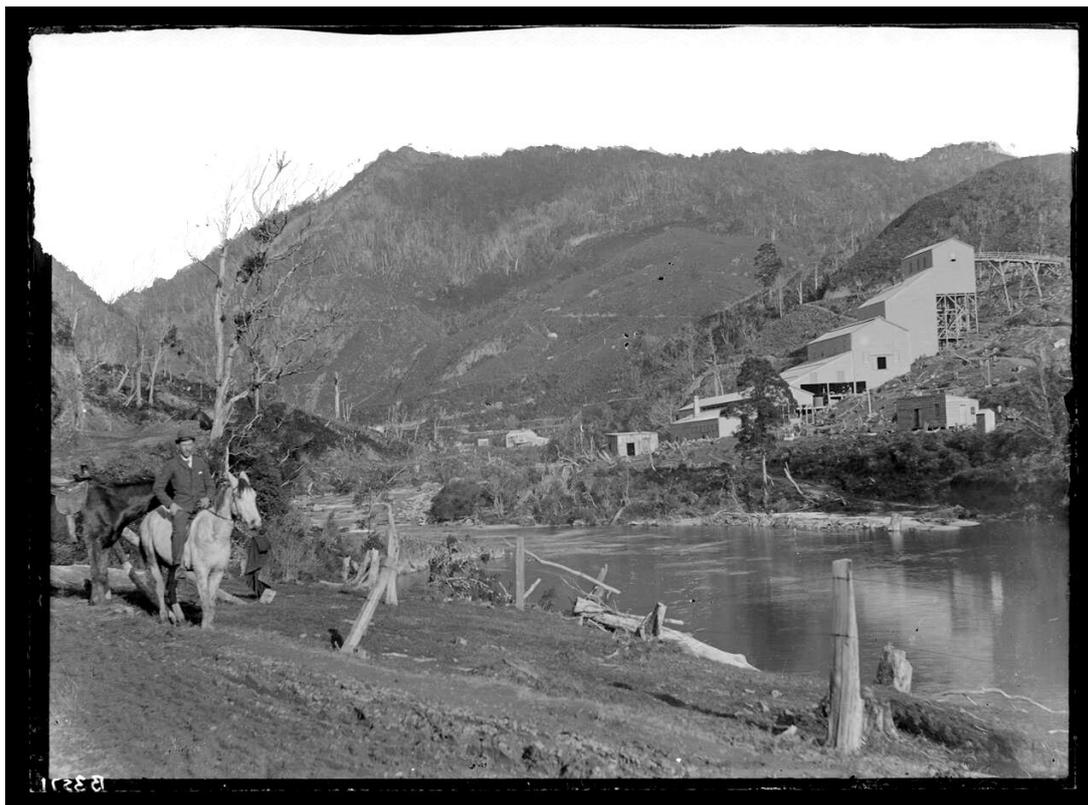
This is a MM White photograph, No B3571.

This is the earliest photograph of this battery. 1893-94?

The kilns are responsible for the masonry work at the top of the current remains of this battery. The trestle work at the top of the battery delivers ore from the ground tramway to the stone breakers at the very top of the battery. The ground tramway cutting can be seen on the spur to the left of the battery. It descends on an angle to Battery Flat. This tramway will be replaced with a level tramway in early 1900.

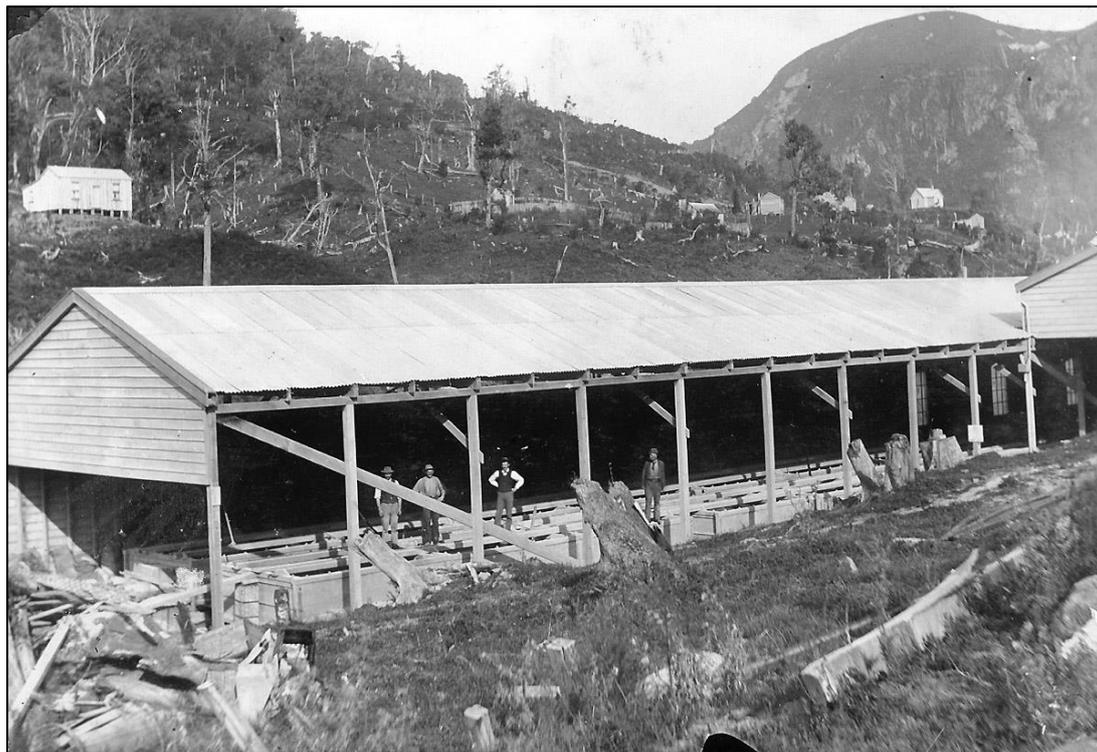
This building holds the percolation tanks. The space on this side of the building suggests the image is of the smaller 20 stamp battery. This space gets filled with buildings when the battery is enlarged in 1896.

The vats are rectangular wooden tanks. “twenty-four wooden vats, each 11ft, long by 9ft. wide and 3ft. 9in. deep.”

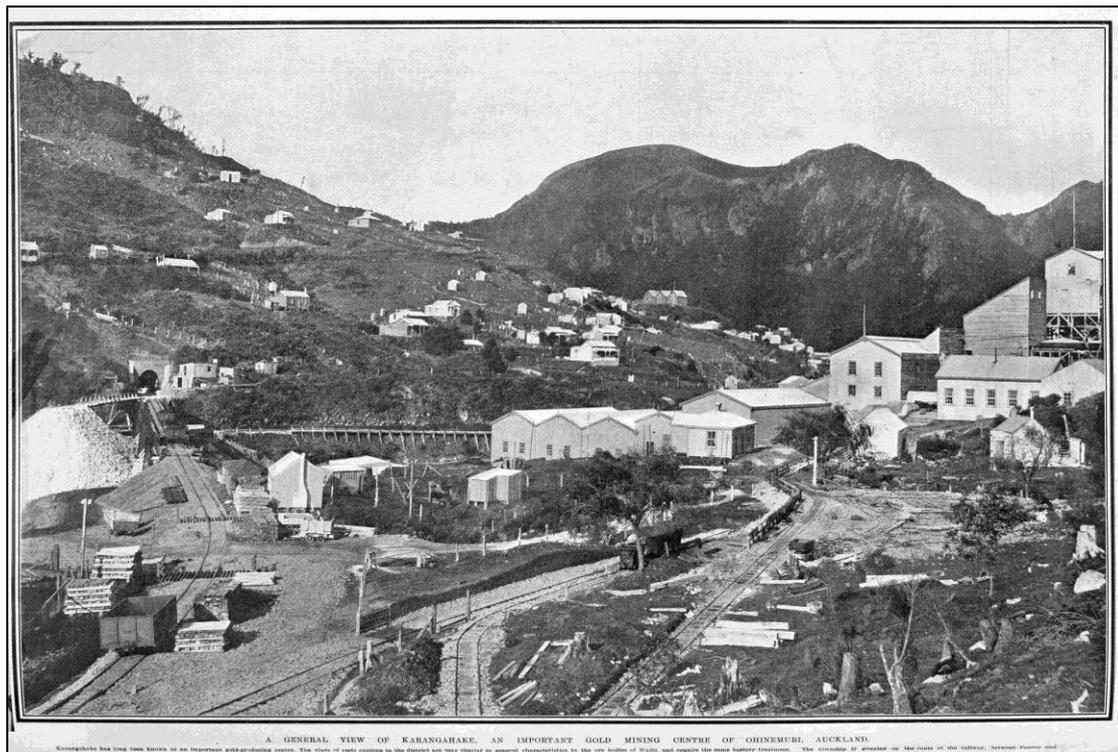
Published by the Auckland Weekly News 23 June 1904.

At left the huge heap of spoil from the railway tunnel, and the temporary bridge to deliver it over the road and into the river. Two coal wagons on the rail bridge, ready to discharge coal into horse carts beneath. This is the end of the line until the tunnel is complete.

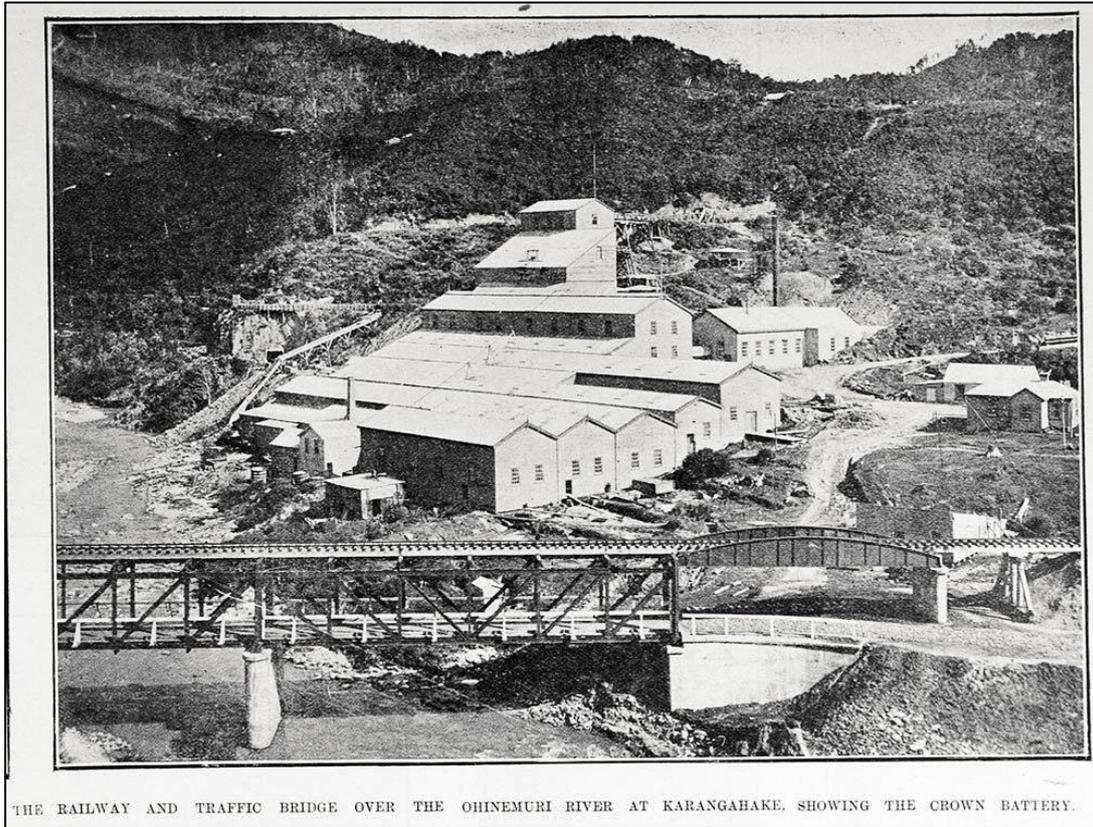
Auckland Weekly News image, dated 16.11.1905.

The ore dryer chimneys have been removed.

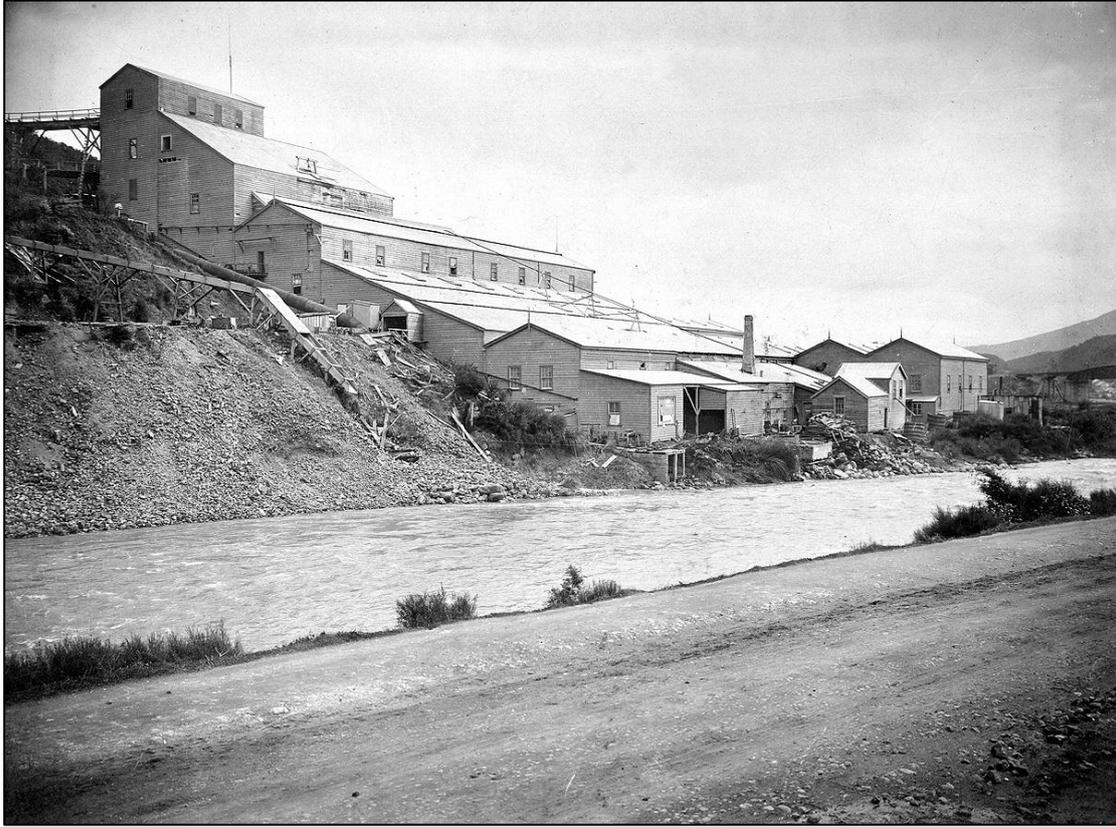
The flume in the foreground is the water race bye wash. The large pipe beyond it is delivering water from the race to the pelton wheels which must be low to the river, discharging at the wooden structure just in front of the buildings.

The rail bridge can be seen at the very right of the image. The river is high; there is not much freeboard.

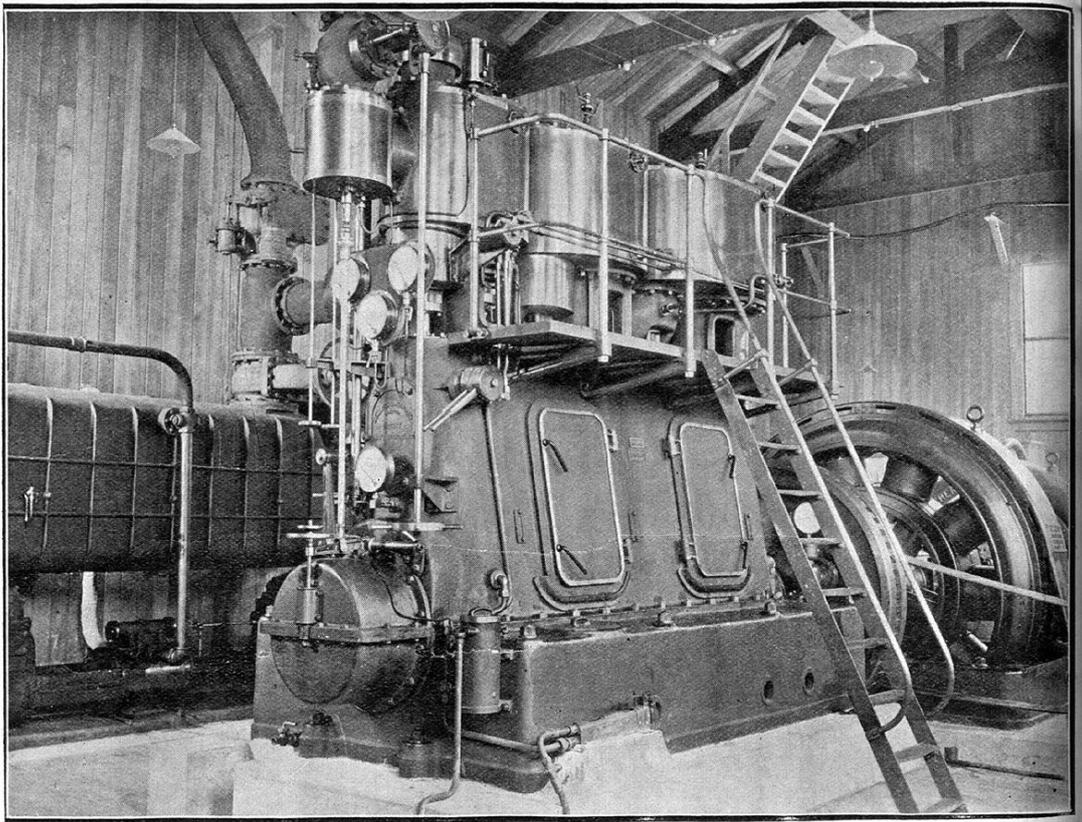
Auckland Weekly News published 4 November 1909.

AUCKLAND'S GREAT GOLD-MINING INDUSTRY: SOME OF THE MACHINERY IN THE NEW POWER-HOUSE AT THE CROWN GOLD MINING COMPANY'S BATTERY, KARANGAHAKE. Oliver and Walker, Photo.

Central in this image is the large triple expansion steam engine (Belliss and Morcam), generator to right, turbine (?) obscured extreme right. Boiler house behind the wall at back, river beyond. The concrete foundations remain. The foundations and subsurface cavities of the turbine area remain a mystery. The concrete tunnel at almost river level is the tailrace for the water turbine, and also for battery tailings?

The foundations that remain show where the steam engine, dynamo and turbine were situated.

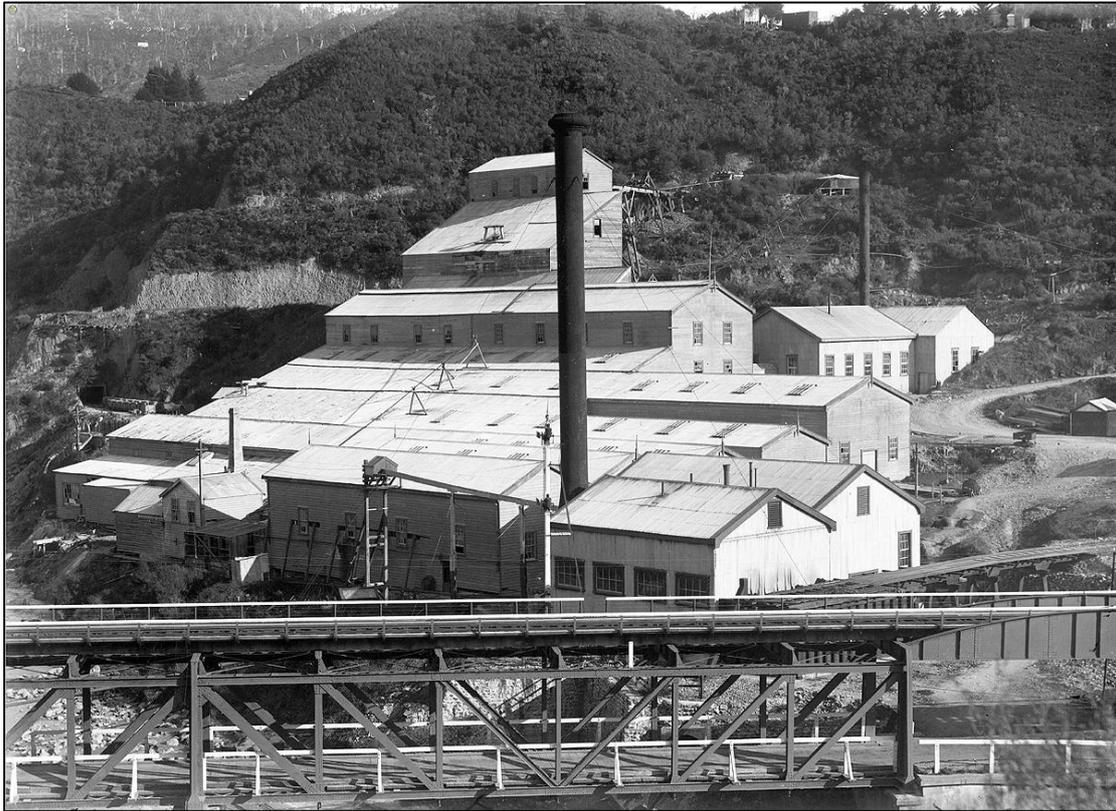
George Chappell photograph.

Through the framework of the road/rail bridge can be seen the substantial retaining wall required to provide space for the boilers and engine shed. The top of the tailrace is just visible.

Above that again are some cuttings from the early, sloped, ore tramway.

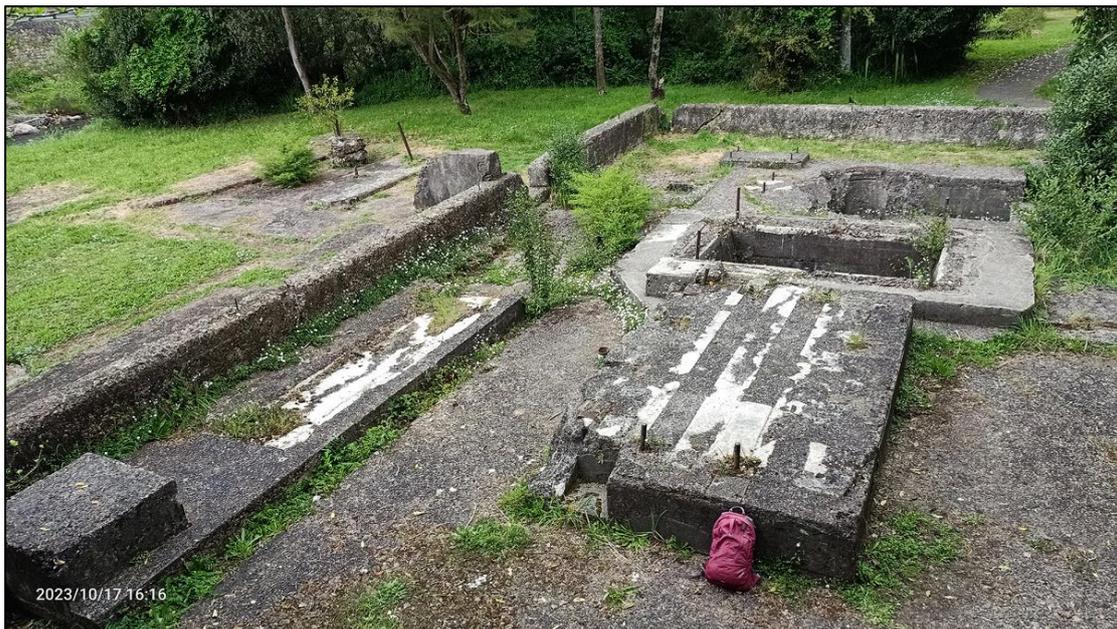
17.10.2023. Crown powerhouse foundations. Centre right front to back: steam engine mount, generator mount, turbine pit/mount. Middle left: heat exchanger mount. Top left, remains of chimney foundations, with boiler house to left.

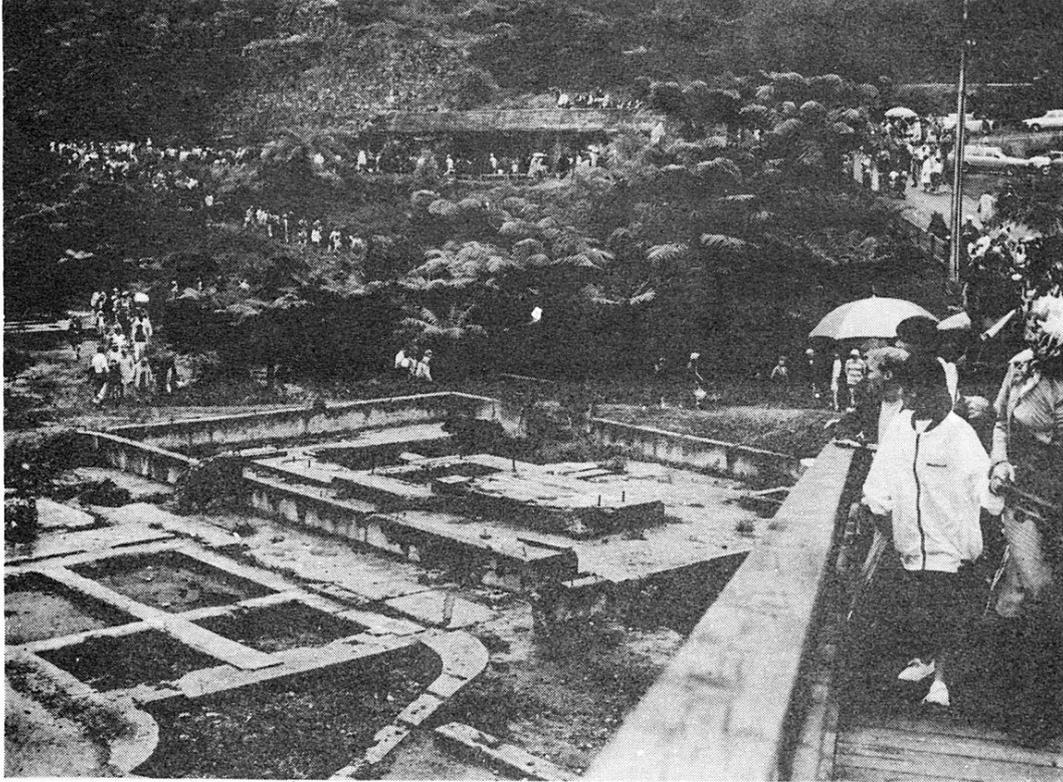
John Greenwood, 2 March 1985.<sup>98</sup>

**The large crowd follows a zigzag course through the Crown Battery foundations at the start of the Walkway. (photograph : John Greenwood)**

This image shows the Crown Powerhouse site, including especially the boiler room foundations.
