Gorge Road, Karangahake

Karangahake Roads and Bridges

First Gorge Road, opened November 1890

Gorge Road Widened, opened late December 1936

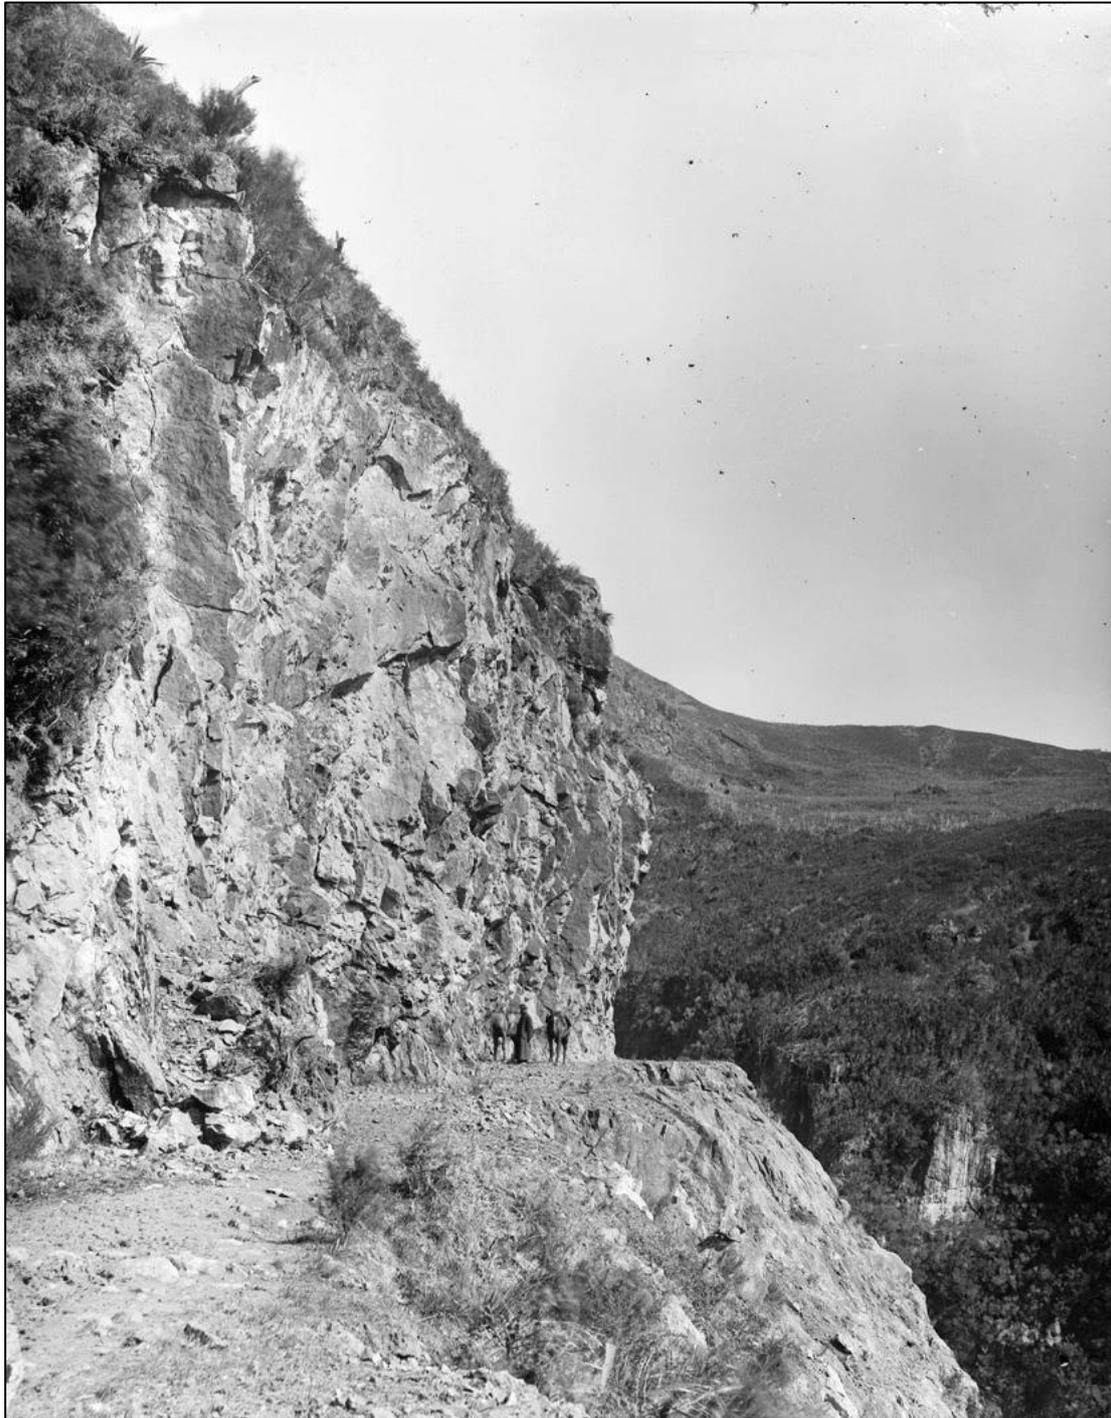
“Cutting on the Gorge Road, Ohinemuri.” Auckland Library, JD Richardson.

This is most likely **Butler’s Track**.

One rider, two? horses. This would be exciting with a horse and cart. Travelling from foreground to background we are travelling towards Waikino. Ohinemuri River below to right. After 1885.

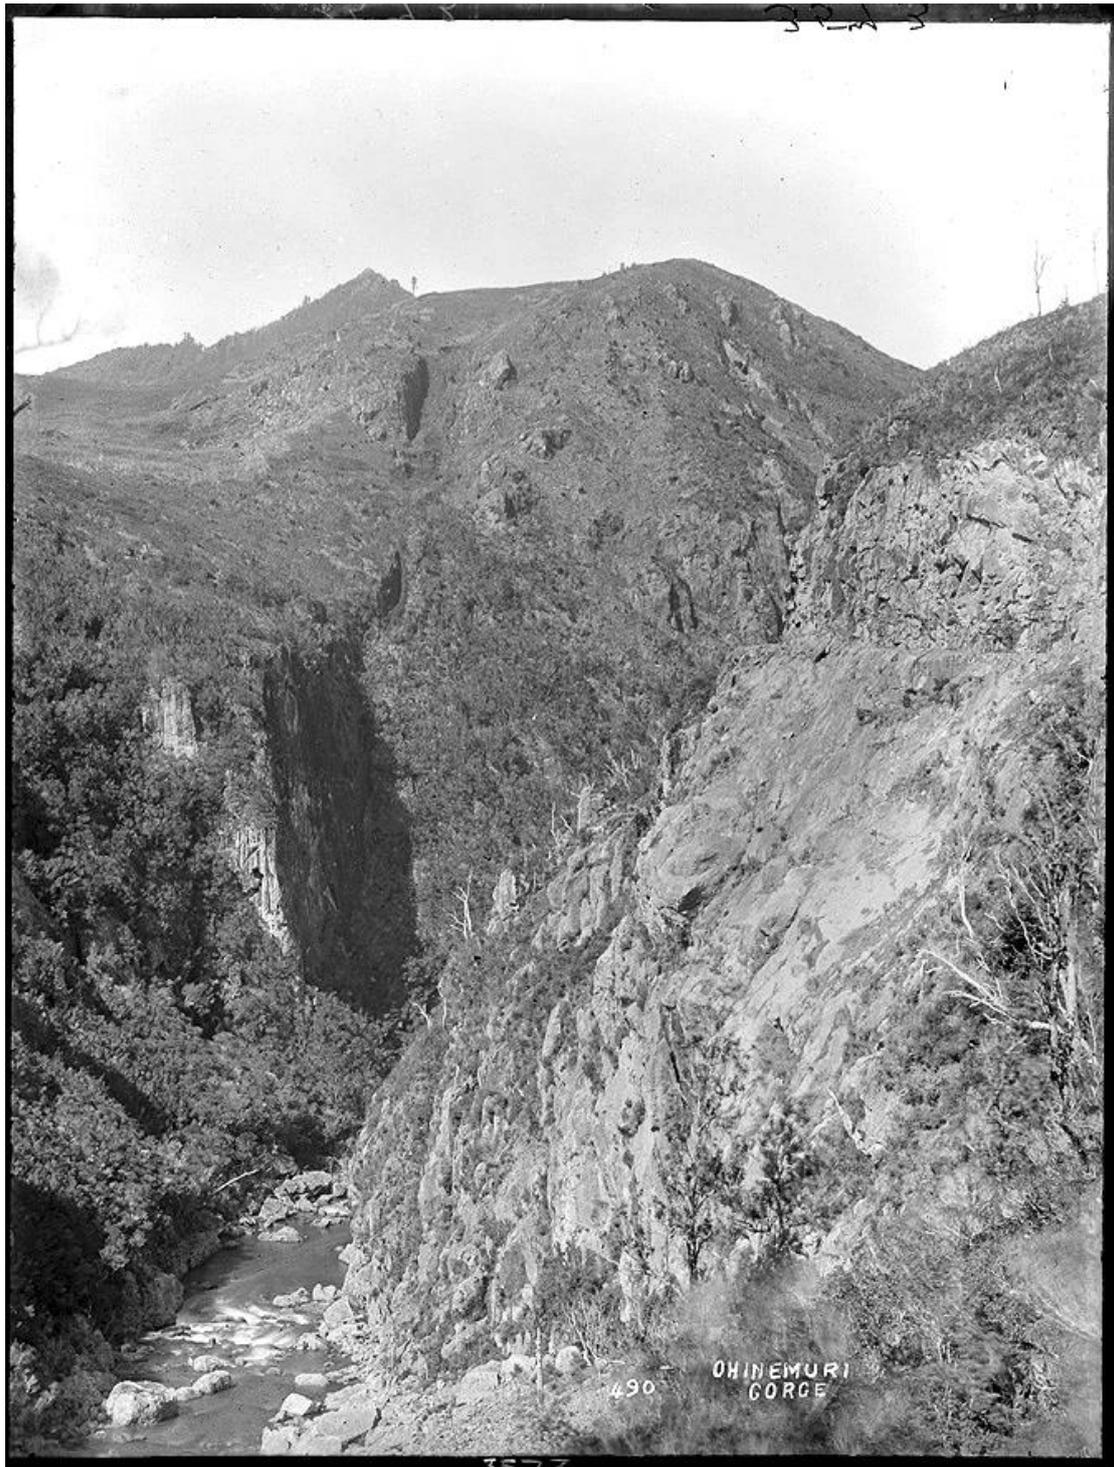
Ohinemuri Gorge 490 Auckland Library, JD Richardson.

A view from Butler's Track, Ohinemuri River below, flowing away from us. The track is near the top of the cliff to the right. Note the abundance of trees. ☺

Date? Before the gorge road (1890), which would be visible beside the river.

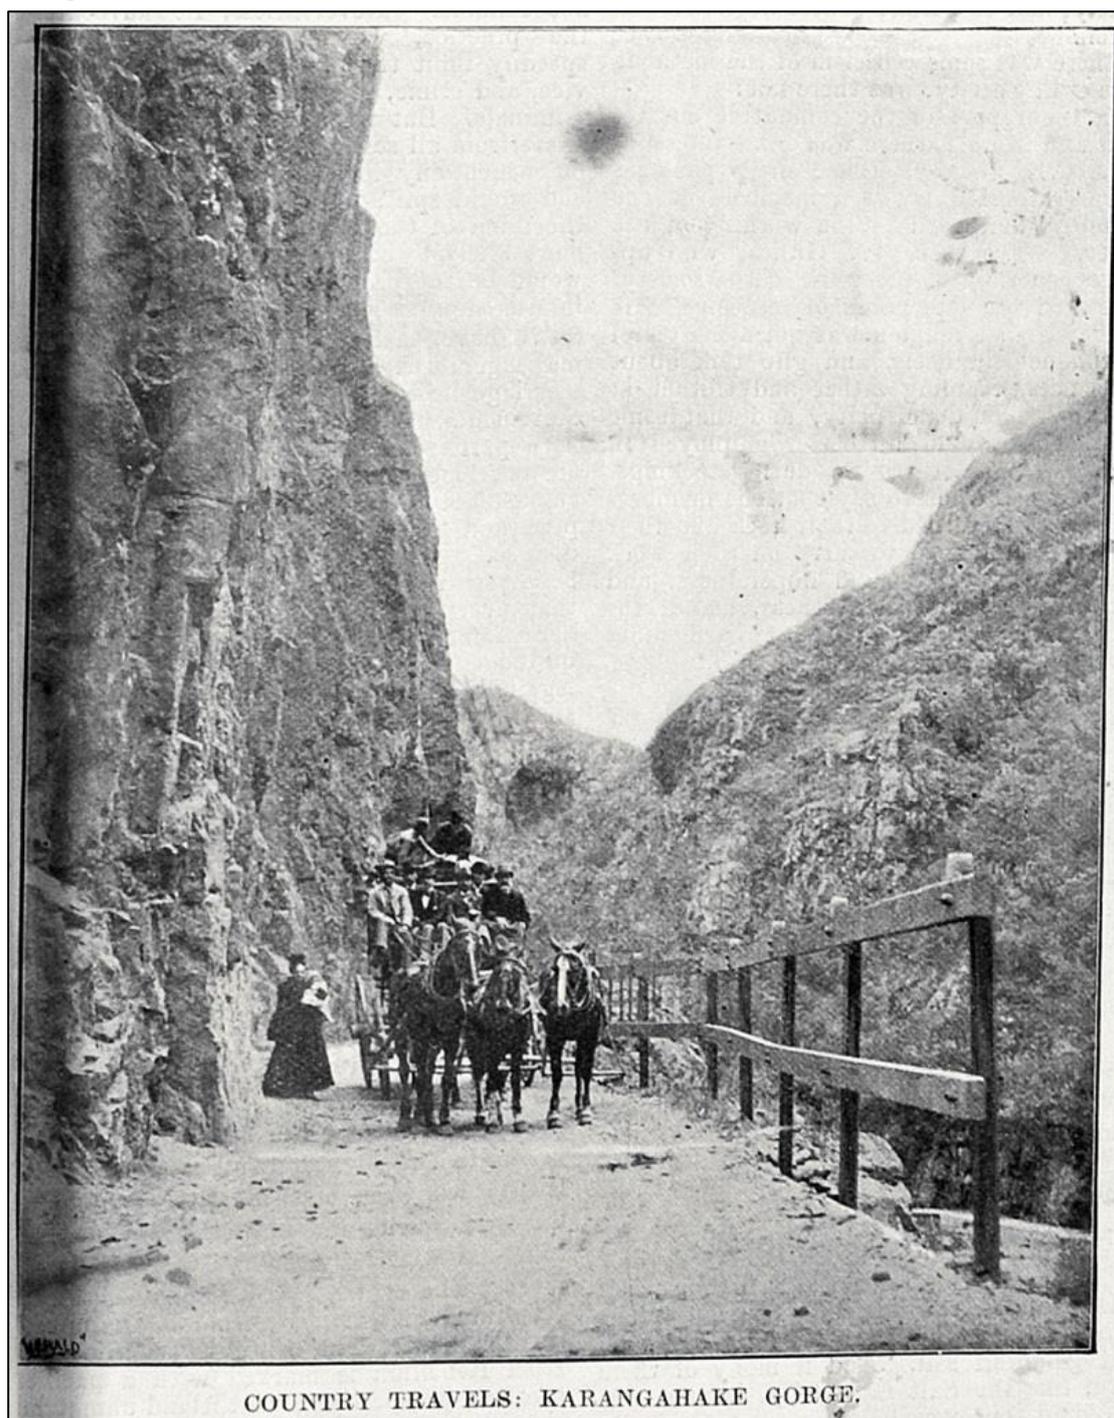
COUNTRY TRAVELS: KARANGAHAKE GORGE.

The safety railing appears to be supported by railway irons

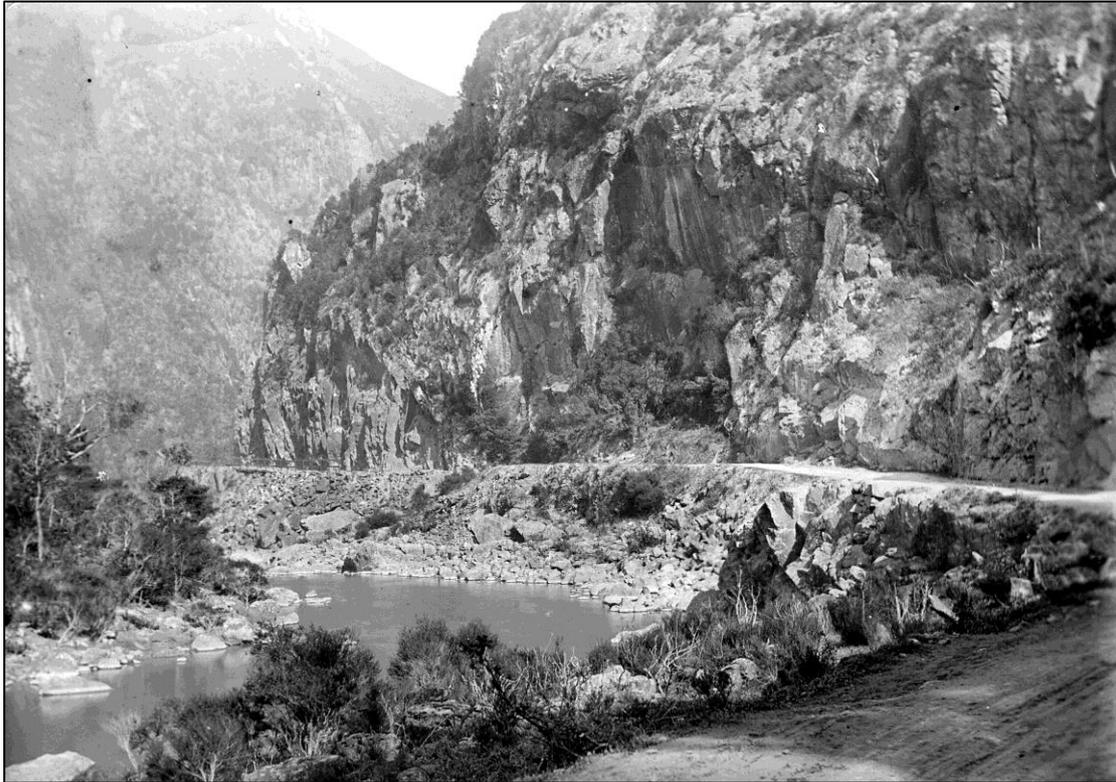
1901. Staples Collection. Photograph taken from the road.

Pre railway tunnel (started c. late 1901), pre Woodstock water race pipe (the dam was constructed early 1900¹⁶, the pipeline late in the year). Image date may therefore be mid 1900.

If the Staples date is close, then roughly ten years after construction. No telegraph poles yet, and the fence/handrail gets extended later.

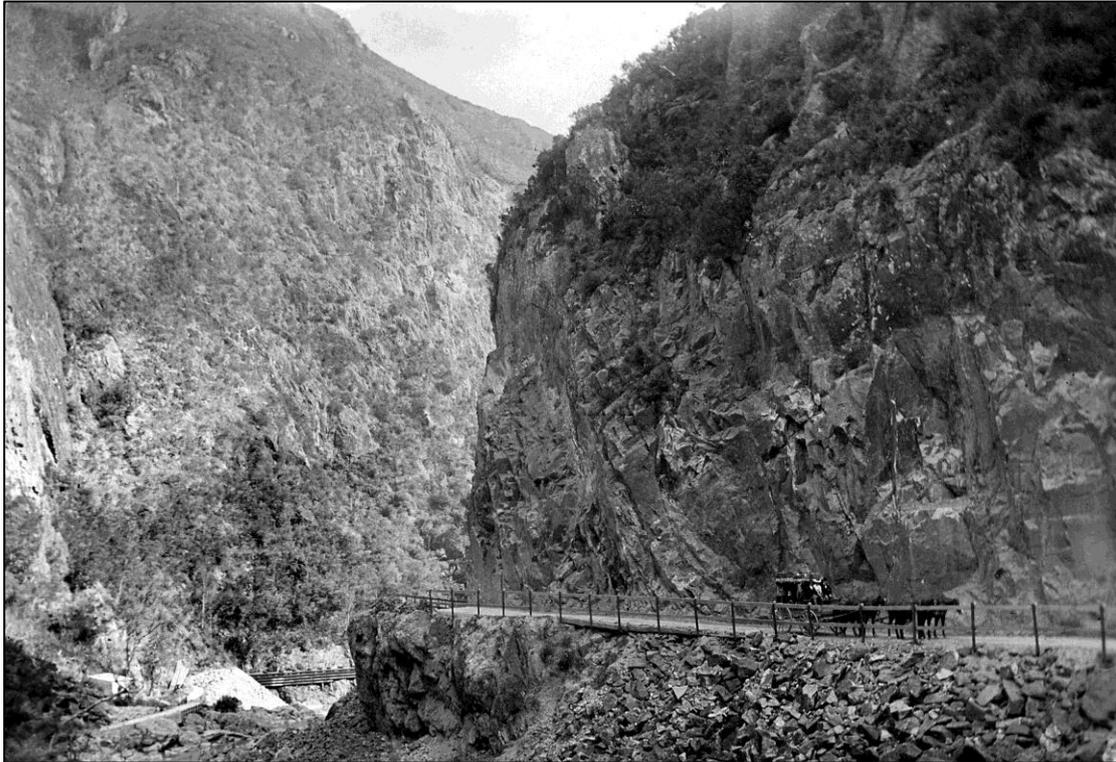
The sharpest corner, and highest cliff is shown here. A stage coach with a three horse team is posing for the photographer. Three people sit across the front seat.

The Crown company's water race flume is bottom left. The pile of mullock is from the adit in the cliff above the flume. The flume must have been well protected for this to be possible. There is a shed to the left.

The water race is well armoured with heavy timbers as it disappears behind the bluff; protection against flood debris damage. Some of the footing timbers can be seen. The notches cut into the rock are visible from the present walkway, which makes use of the bench cut for this water race flume.

There appears to be no large water race pipe on the riverbank below the road. The Woodstock dam and pipe constructed 1900 1901.

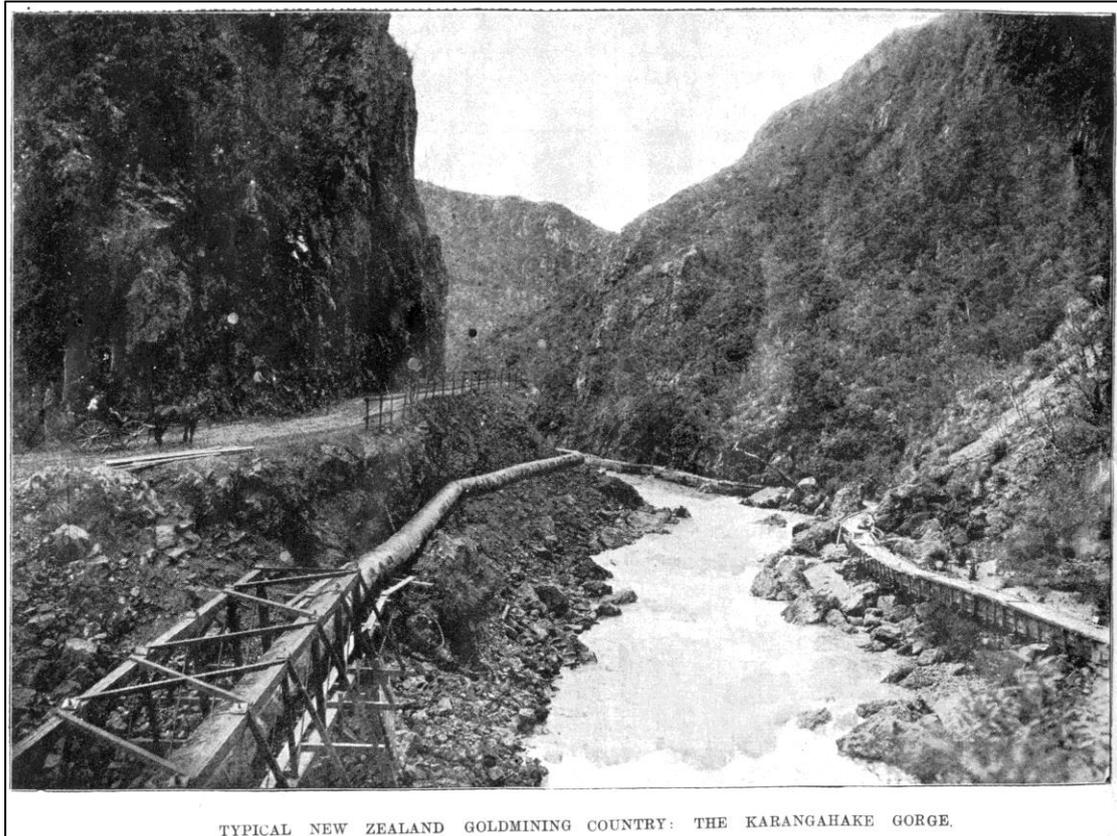
Auckland Weekly News photo, 1901.

To the left is the Woodstock water race pipe from their new dam. It was completed May 1901.¹⁷ The Warren Truss¹⁸ bridge takes the pipe across the river. The Crown Company's water race flume is to the right (true left bank). Note how it weaves between the boulders in the middle distance. Further upstream it sits on an excavated rock bench, still clearly visible today.

The photograph was taken from the stoney bluff above the present walkway (the bench cut for the Crown flume).

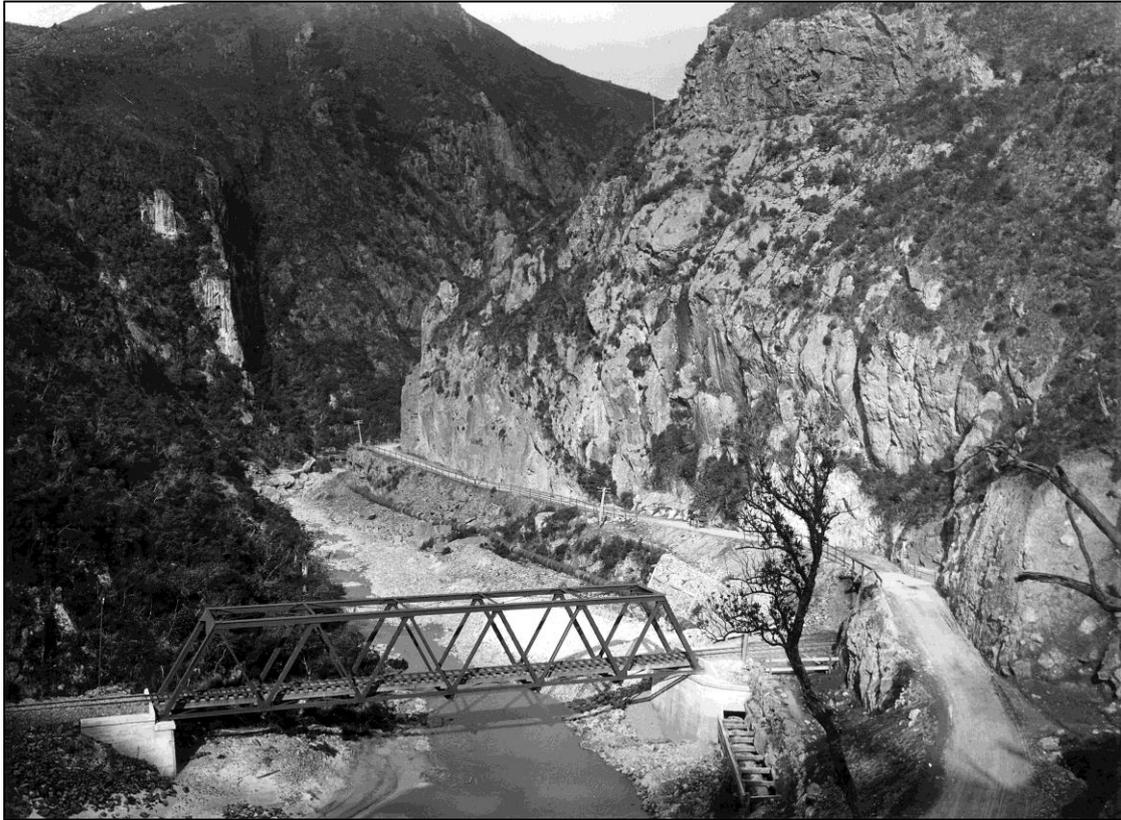
This is Winkelmann photograph 983, 1906. Staples Collection. Photograph taken from well above the road.

The road over the tunnel mouth was completed circa end 1905. It was achieved by cutting back the cliff. The road was widened during 1936 by extending the tunnel entrance with concrete. The fence asked for in 1905 can be seen. Also a fence alongside the road above the river.

The river level is low; the Woodstock (now Talisman since mid 1904) dam a little further upstream is sending much of the flow to the battery via the large pipe. The water is dirty from the discharge of Victoria, and other upstream batteries.

The Crown battery wooden flume is visible on the river bank in the distance, with the extra wooden baulk "armour" at the bend of the river. The current walkway makes use of this bench.

Butler's Track can be seen at top right of image, complete with telegraph pole (which still exists?).

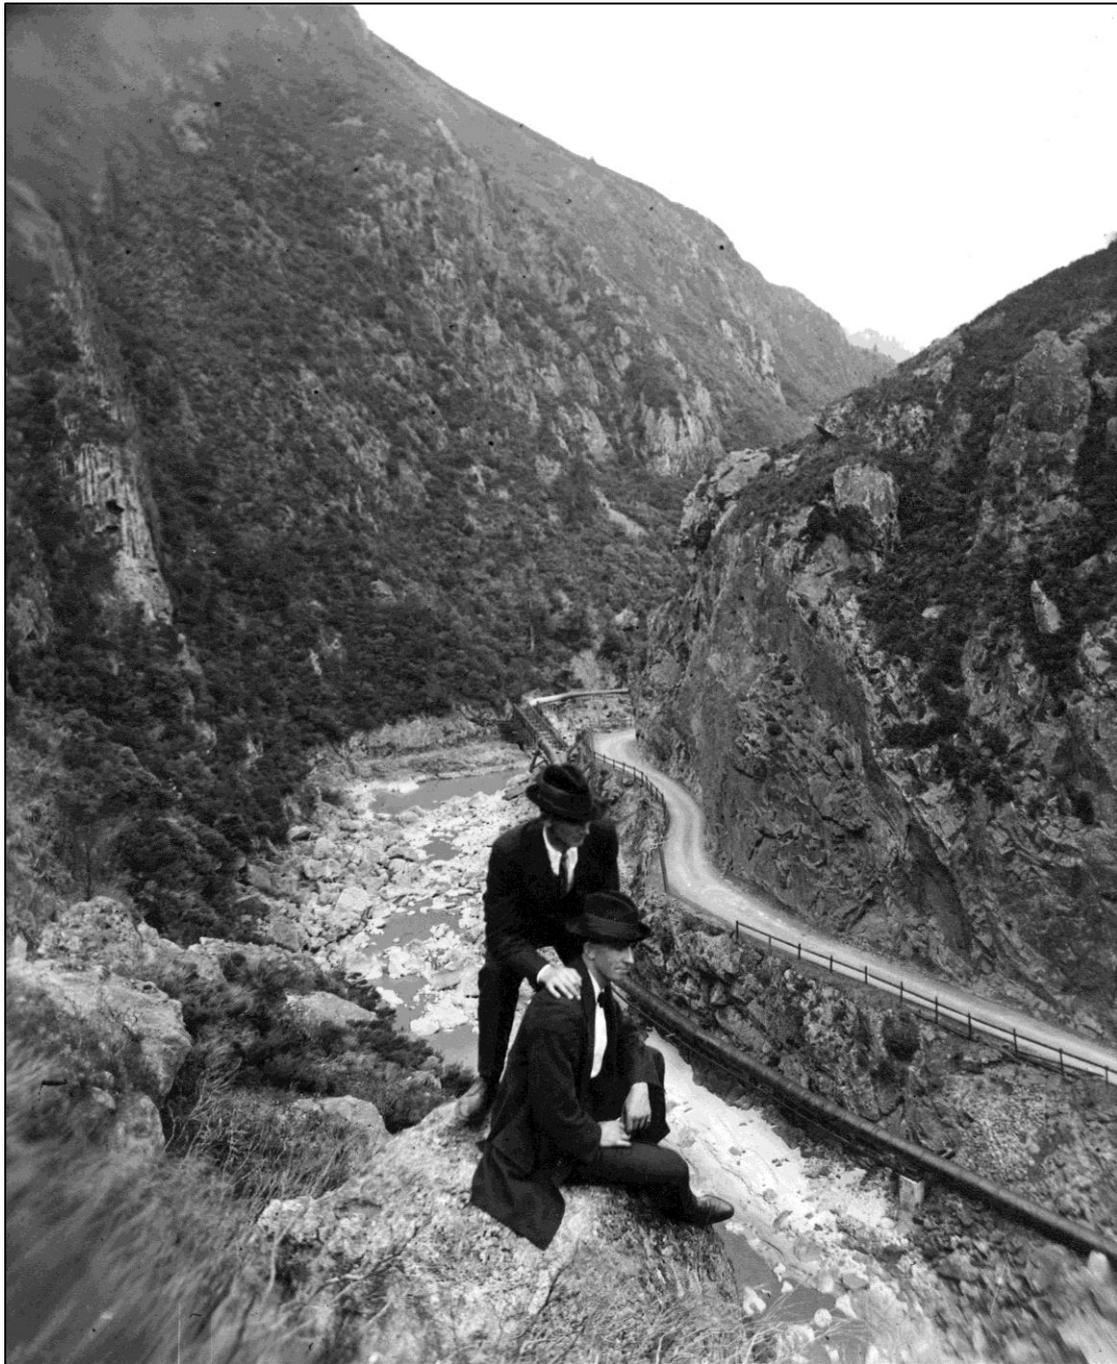
Photograph taken from high above the railway bridge, true left bank of the Ohinemuri. Staples Collection.

Notice the bend in the roadway (to the right of the head of the upper figure). This is the section that is widened (1936) by building out into the river, as reported in the articles above. This wiggle in the road is not there today.

The road is clearly unsealed, and one way, with little opportunity for passing. Imagine that today :). The Talisman water race pipe is prominent, with the Warren Truss¹⁹ bridge which took it across the river. Bolts, cables and footings of this bridge remains today.

The river level is low, suggesting the Talisman dam and water race are still capturing water. Note the white, silty tailings in the river bed.

The Crown water race flume has gone. The bench it occupied is clearly visible to the left of the bridge. We walk on this bench today. When was the flume removed?

The Crown battery stopped work in mid 1914²⁰. It may have been several years before the flume was removed. If the Talisman is still using water, this would suggest a date of before end 1920, when the battery ceased operation.²¹

There is evidence that the 1909 upgrade of the water race for the new Crown powerhouse was never completed, so the flume may have been removed shortly after that date. In any event, the Crown dam, below the two figures, would only be capturing the water not taken by the Talisman dam upstream.

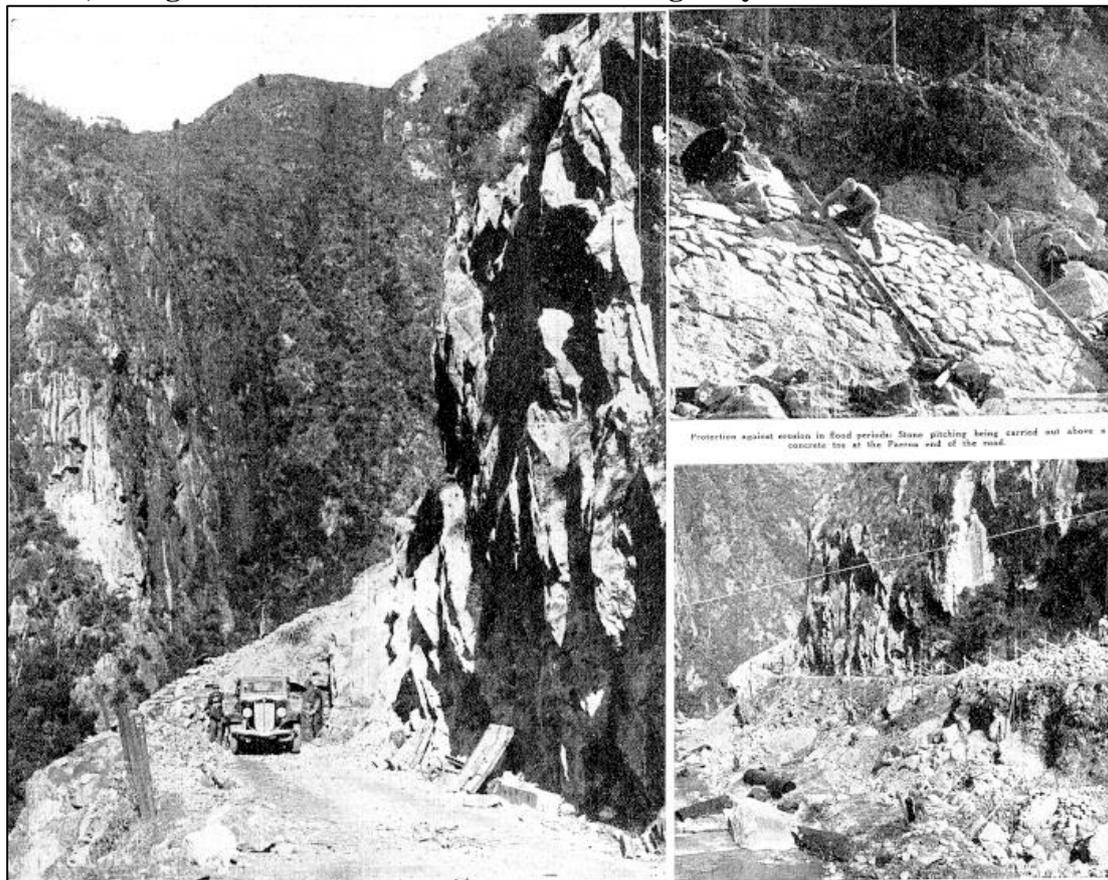
Old Narrow Road Through The Karangahake Gorge, On The Paeroa – Waihi Route, Being Transformed Into A First-Class Highway

1936, New Zealand Herald.

The caption under left image: Where a bad bend in the gorge road is being eased and widened. The road alignment will encroach into the river-bed at this point and will be protected by a grouted rock wall built on a solid concrete base. This method is preferred to cutting into the precipitous rock walls of the gorge.

Top right: Protection against erosion in flood periods. Stone pitching being carried out above a concrete toe at the Paeroa end of the road.

Bottom right: This view shows the proximity of the road to the river and the need for protective rock facings below the widened highway.²²

To obtain the width and alignment stipulated for modern highways, the building of the new road out on to the river bed in places has been found preferable to cutting into the precipitous rock walls of the gorge. Protection against erosion in flood periods will be a necessary safeguard, and the construction of rock faces is in hand. At the Paeroa end a long length of stone pitching above a concrete toe, with fillings completed to road level, gives a good indication of the finished appearance of the new highway. At one point the road alignment will run right out on to the river bed for approximately two chains.

The extremely low level of the river during the last few months has enabled the work to be expedited and has obviated delay in completing the foundations of the protective works, which are now well in hand and up to schedule. The exceptional flood last February, when the river rose 3ft. 6in. above the level of the previous record of 1910, proved a valuable experience for the engineers in providing against any possible eventualities.
