Railey's/Crown Battery site photographs

There are eleven known images of Railey's site and infrastructure, only five show buildings. It appears that none show Railey's battery! What was originally considered to be the battery is most likely the much later Crown compressor building.

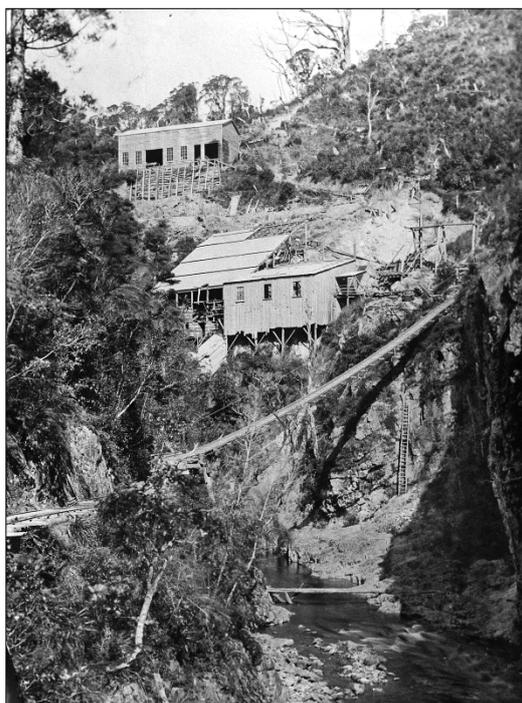
Construction of Crown battery and Cassel plant.
M.M. White?

There is no hand rail on the bridge, a luxury that was added later. Workmen, not prepared to risk a fall from the bridge, cross the river on a low log bridge, and scale the cliff by ladder. The wire used to haul ore across the river can be seen. This wire, or one of the bridge wires, is present today.

There are rails on the tramway, though somewhat awry. There does not appear to be metal rails on the bridge, but there are slats fixed cross-wise to assist walking or pushing of ore carts. The Crown company will use this route, previously established by the Monastery mine company, to deliver ore to the site from their No.6, or river level, adit.

The lowest part of the Crown building is presumably above the pelton wheel shaft. Three wooden barrels can be seen beyond this in the unfinished portion of the building. One can be seen in the Cassel building. In front of the Cassel building appears to be a bank stabilization/retaining wall of logs.

Is the finished part of the building, with the three windows, a remnant of Railey's building? There is no sign of the stone pillar seen in subsequent images. Was it the foundation of a step kiln, used to dry the ore prior to reduction?

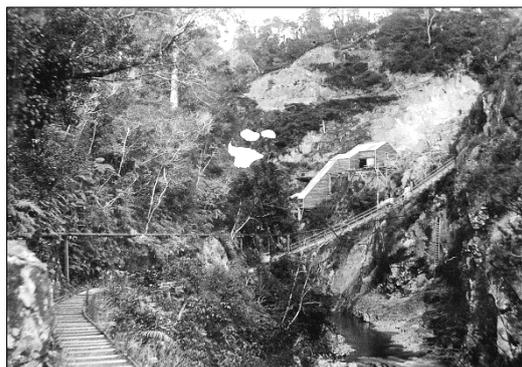
Compressor building. MM White.

Large area clear of vegetation (from the slip August 1890?⁴). Benching above and east of the building left over from the Cassel buildings. Looks like some timbers remain on the middle bench.

Compressor building configuration, but with scaffolding on both sides. Why the scaffolding? Building still in progress?

Ladder up cliff from river.

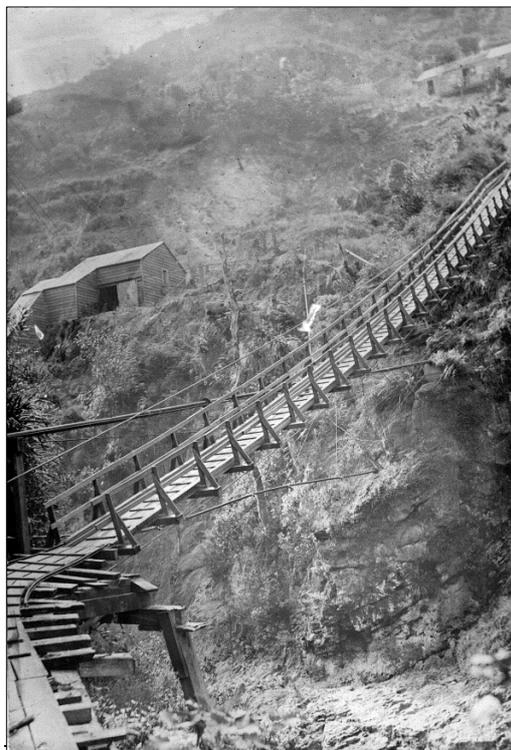
Compressor and swing bridge.

Bridge held up on cables, ie a swing bridge, not suspension bridge.

Two pipes cross beside bridge, the smaller one suspended on cables. Note the larger pipe supported on other side of stream by concrete pile.

Stone pillar, and what might be a chimney pipe visible to right of building.

How was the single cable above the bridge actually used? Were there rails on the bridge

to start with? A short section of curved rails remain, with the suggestion of rail having been removed from lower down the platform. So no longer moving ore carts? Straightish rails removed to be used elsewhere?

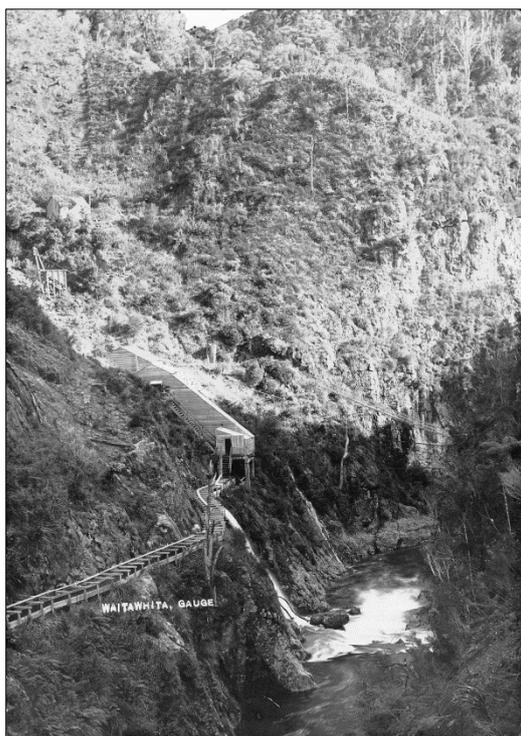
Waitawhita Gauge

Interpretation of the building layout: the top section of the building houses the air

compressor, securely located on flat ground. The bottom section is above the pelton wheel shaft and the end of the flume. Here water enters a pipe which carries water down to the pelton wheel nozzle/s, and a steel shaft brings the rotational energy up to the building. A continuous belt takes the power up to the compressor in a covered way. A well protected, important asset.

Water discharging via by-wash, no sign of pelton wheel exhaust at river level, so compressor not in operation.

Air and water pipes going across the river. To Crown mine?

The ore hopper under the cable, presumably collected ore from across the river, via the cable. Placed higher than the battery so that ore could move to the battery with gravitational assistance. But

how? May be a chute or pipe, but if so, it has been removed. No longer used.

Stone pillar maybe visible just to left of upper most roof of battery. See previous photo. What was it for? Remains of the step furnace installed at the battery in 1890?

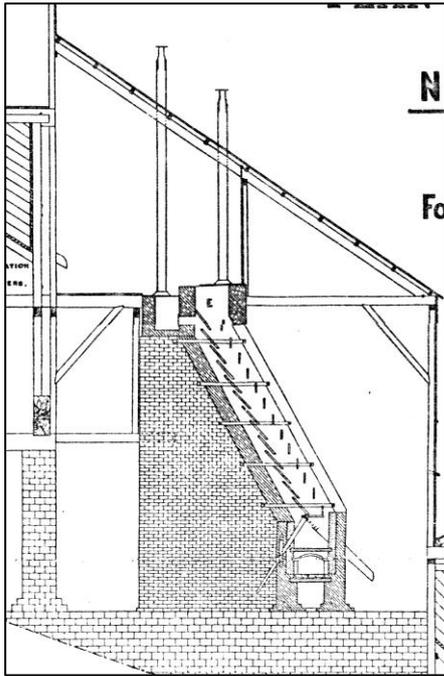
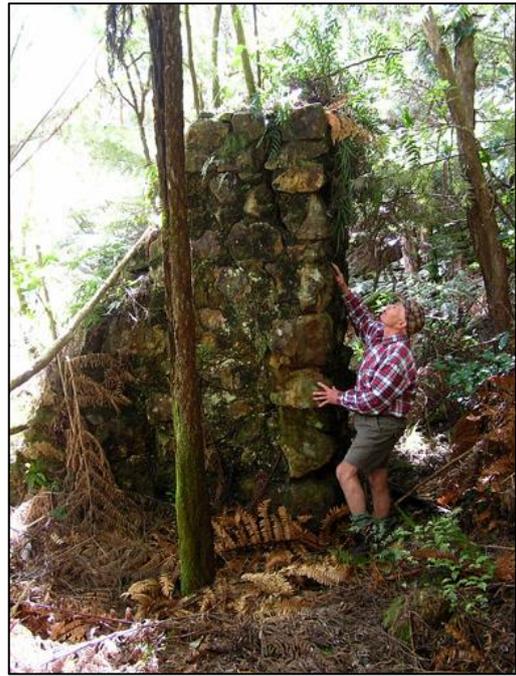
Similar furnaces are built at the new Crown battery, a plan drawing of which may show us what they looked like. They are erected against a steeply sloping brick/masonry wall, which can still be seen at the ruins of the new battery today.

To left is a detail cropped from “Plan of 40 Head Dry Stamper Battery” 1893 (new Crown battery), and to right is the image taken at the Railey/Crown battery site, 2007¹⁰

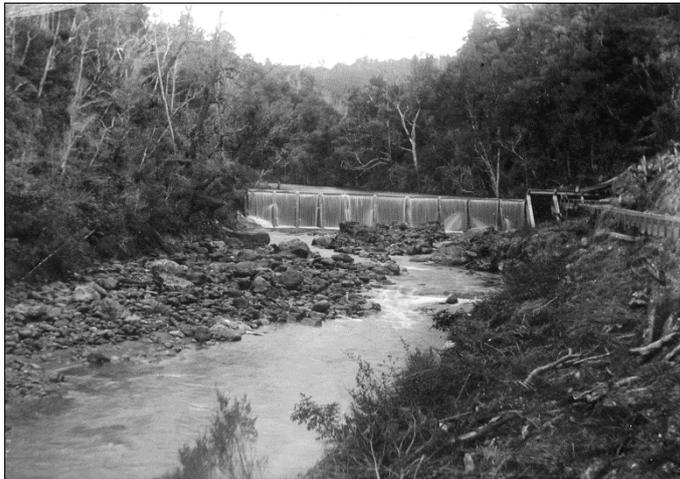
Railey's/Crown dam. MM White

Note the raised section of dam to protect the flume intake.

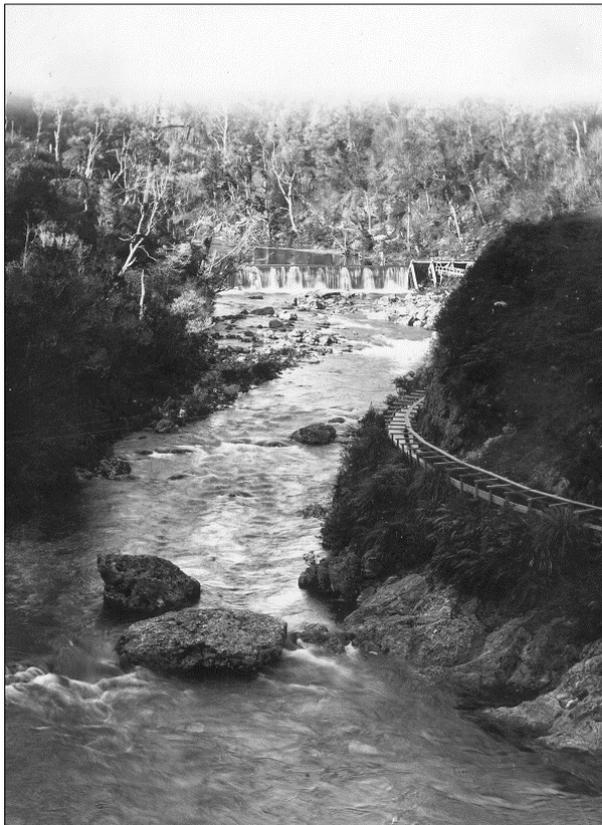
Railey's/Crown damand water race

This image¹² was taken from the Crown water race bench on the true right bank; we can stand there today. It shows the wooden flume on the river's edge. The two large boulders are still present in the river. The upstream boulder sports two eye bolts on the upstream side. They look most like anchor points for stabilisation cable/s of a suspension bridge. Could there have been a bridge to the house from the Crown water race?

Two cables can be seen crossing the river, from the dark headland on the right.

The bench that held the flume is also still present, and more or less navigable on foot.

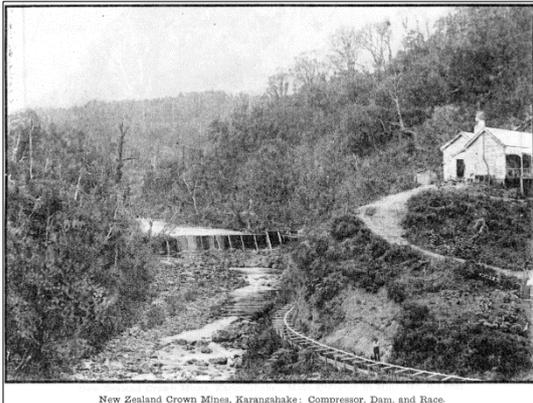
This image¹⁴ is from the Mines Record 1902, the caption reading: "New Zealand Crown Mines: Compressor, dam, and race". However, the structure above the race is clearly a dwelling, evidence of which can still be found (brick hearth, shards of glass and crockery). The image may of course be earlier than it's publish date, but suggests a long period of use for this compressor/site by the Crown Co,

New Zealand Crown Mines, Karangahake: Compressor, Dam, and Race.

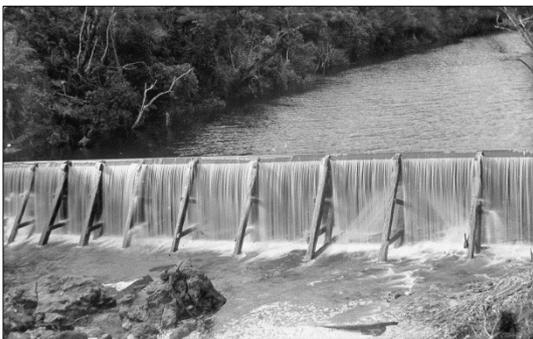
A closeup¹⁵ of the dam, highlighting its construction. Some timbers of the dam remain today, both sides of the river. Margaret Matilda White photograph.

Railey's/Crown damdetail. MM White

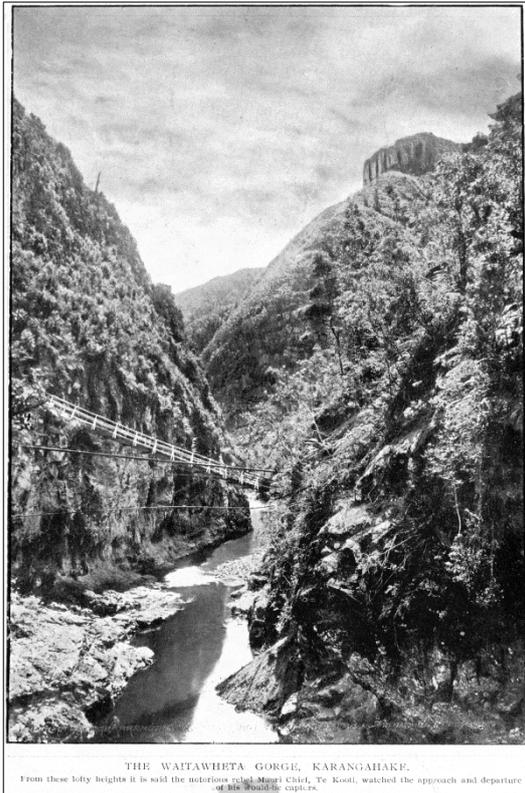
The Waitawheta Gorge, Karangahake

This view¹⁶ looking downstream shows the bridge, and compressed air pipe/s.

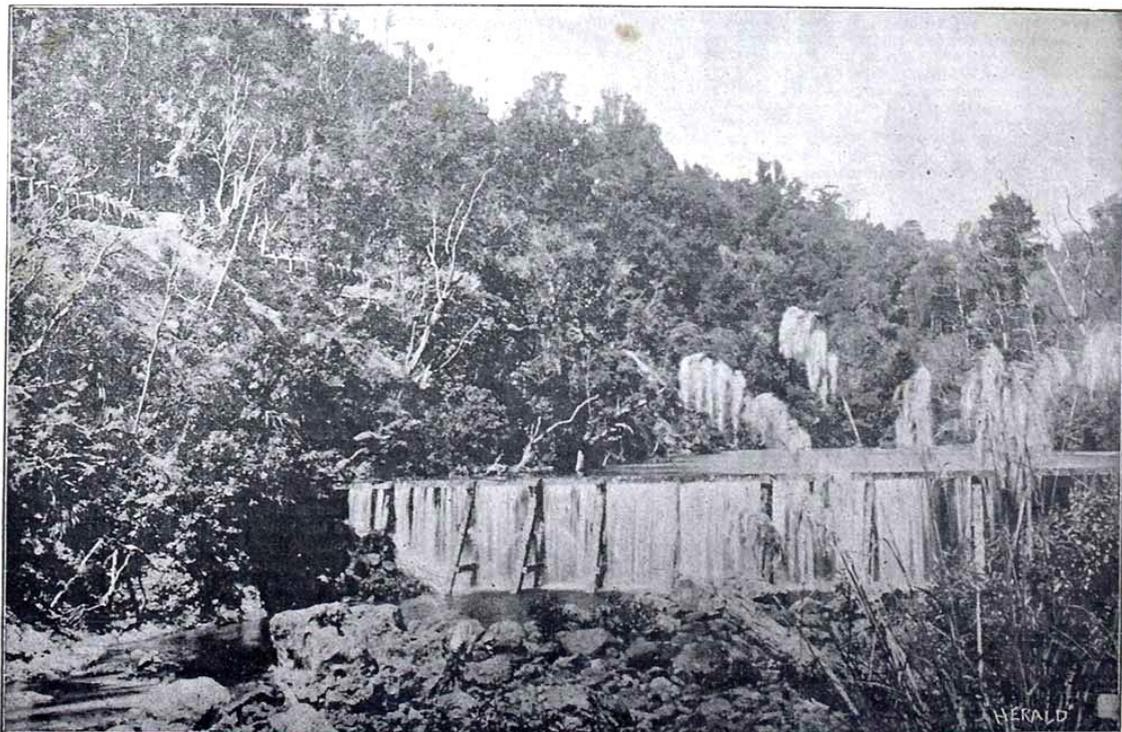
The image¹⁷ below, from the Auckland Weekly News dated 23 July 1898, shows the recently installed flume (in the bush, mid to top left of image) for the new large pelton wheel/compressor, installed c. 1896.

N.Z. CROWN G.M. CO.'S DAM AT WAITAWHETA GORGE, KARANGAHAKE.
